**CALSPAN ON-SITE INVESTIGATION OF TWO COMPRESSED NATURAL GAS
(CNG) CYLINDER RUPTURES
CALSPAN CASE NOS. 94-19 AND 94-20**

VEHICLES - TWO 1992 GMC SIERRA 2500 PICKUP TRUCKS

**CALSPAN CASE NO. 94-19 AND CASE NO. 94-20
COMPRESSED NATURAL GAS CYLINDER FAILURES
1992 GMC SIERRA 2500 SERIES PICKUP TRUCKS**

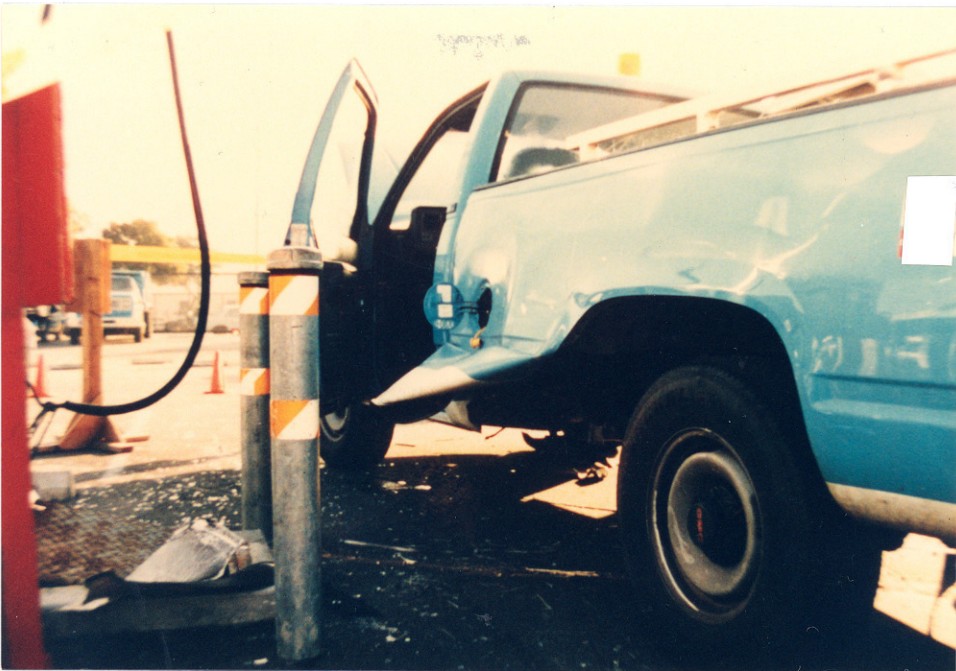
2. Left Side Damage to the CNG Truck Body and Debris

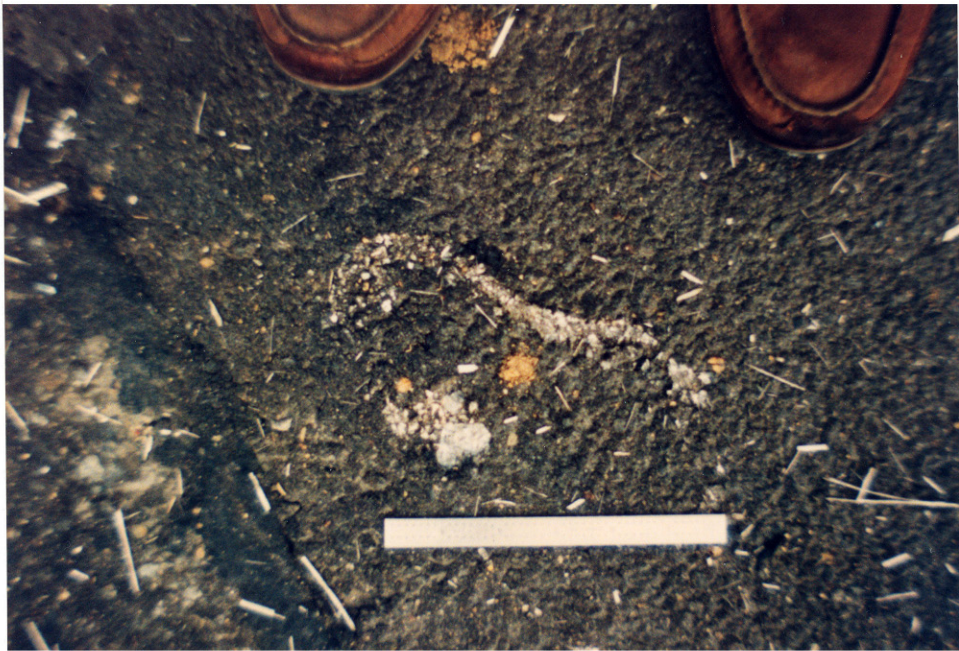
7. Additional Fragment Contact with Asphalt Surface

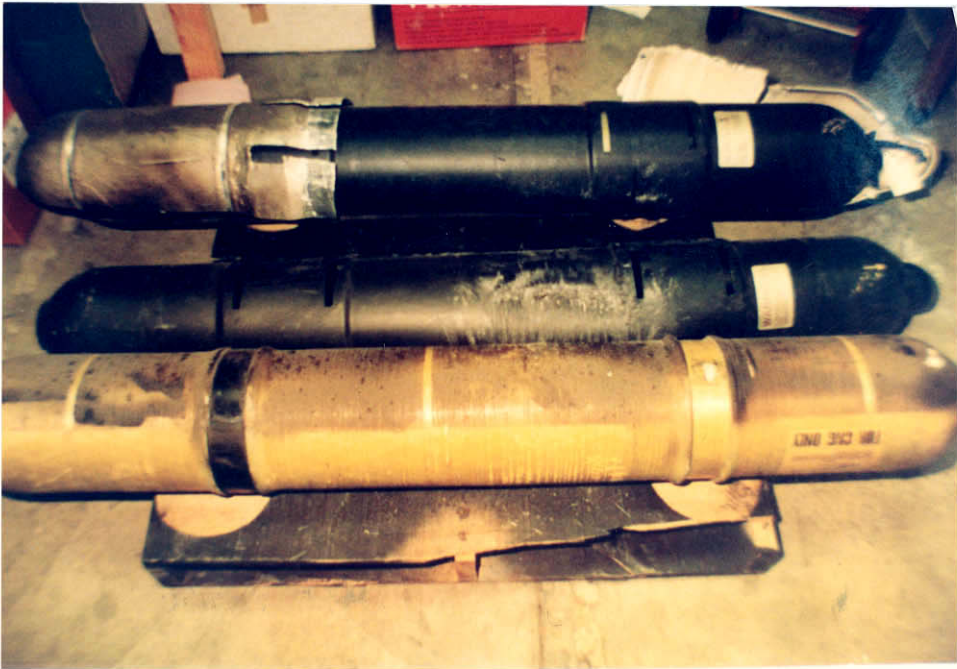
27. Removed Center and Right Cylinders and the Respective HDPE Shields

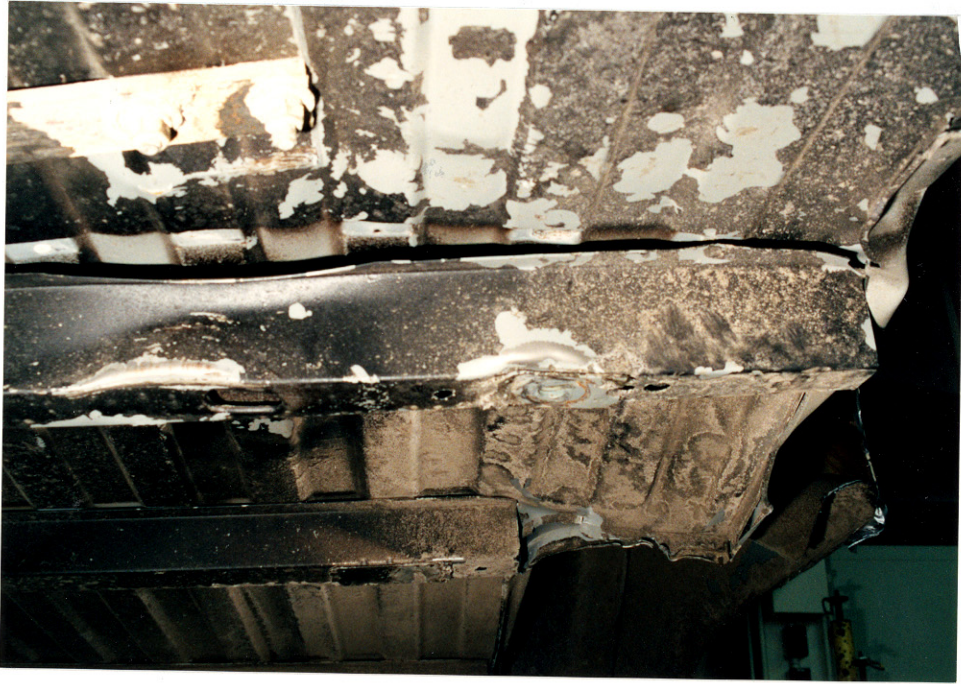
17. Close-up view of the cargo bed looking from front to back along the left side in the area over the failed CNG tank

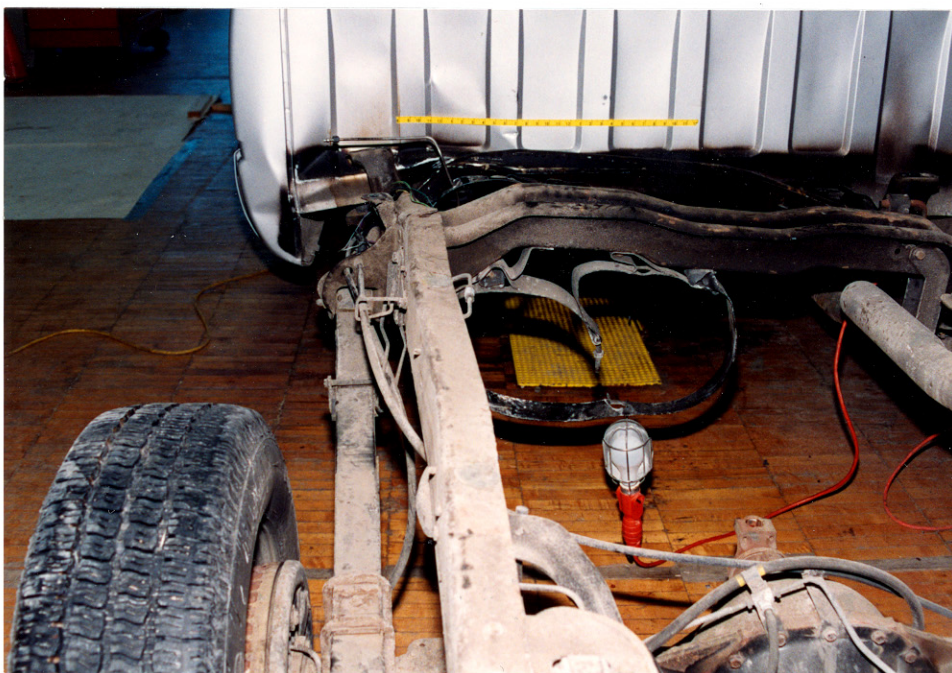
23. View of the left frame rail looking from the rear toward the passenger cab

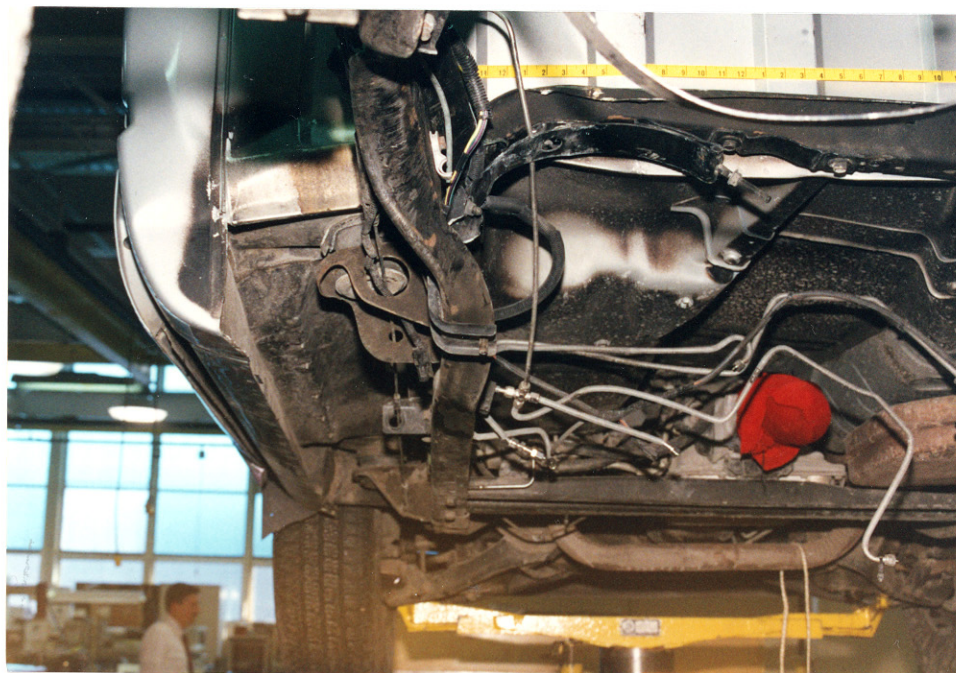
24. View of the left frame rail showing the lateral displacement from underneath the vehicle

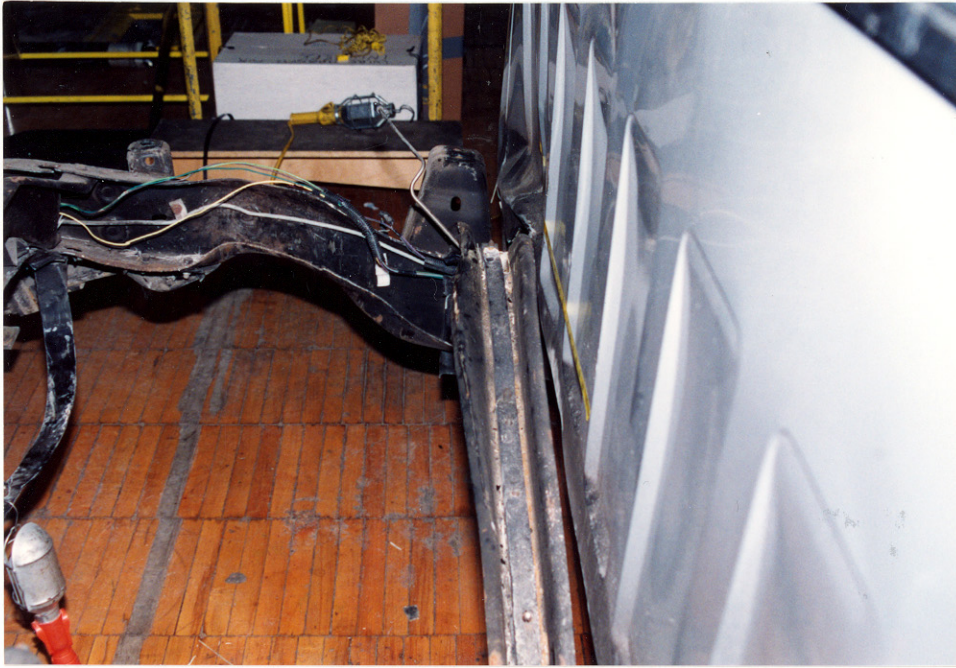
31. Lateral view of the left frame rail from the right side of the vehicle with the rear surface of the cab along the right side of the photograph

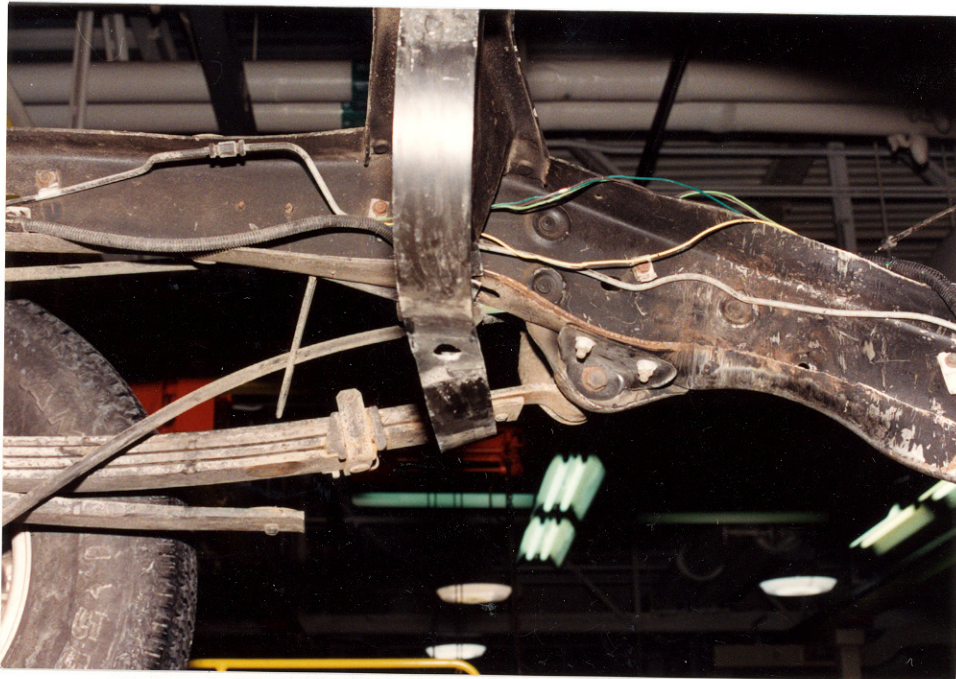
32. Close-up view of the rear tank strap and left frame rail from the right side of the vehicle

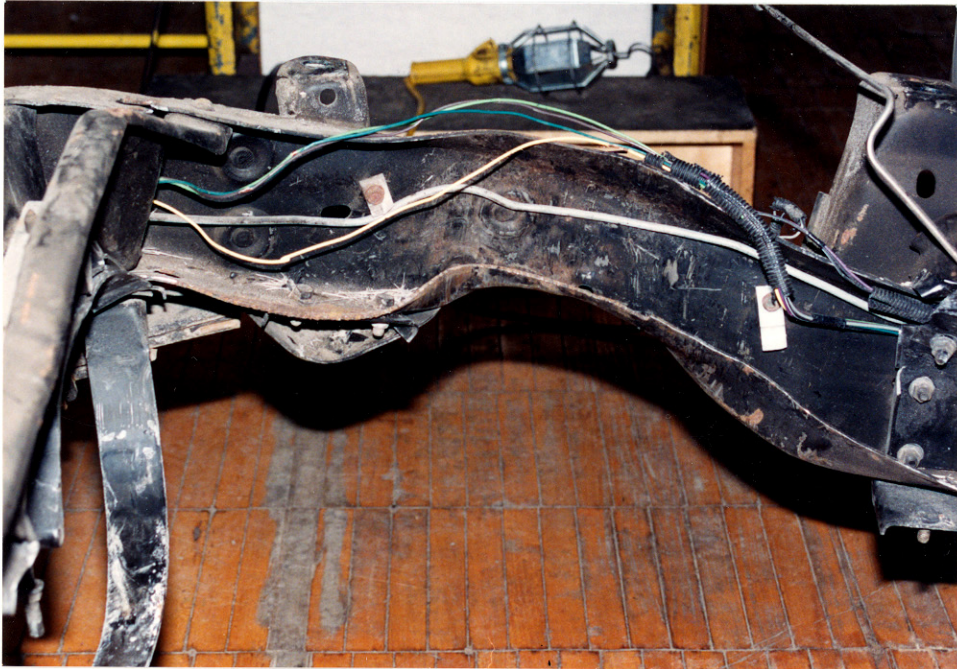
33. Close-up view of the left frame rail adjacent to the site of the CNG tank failure

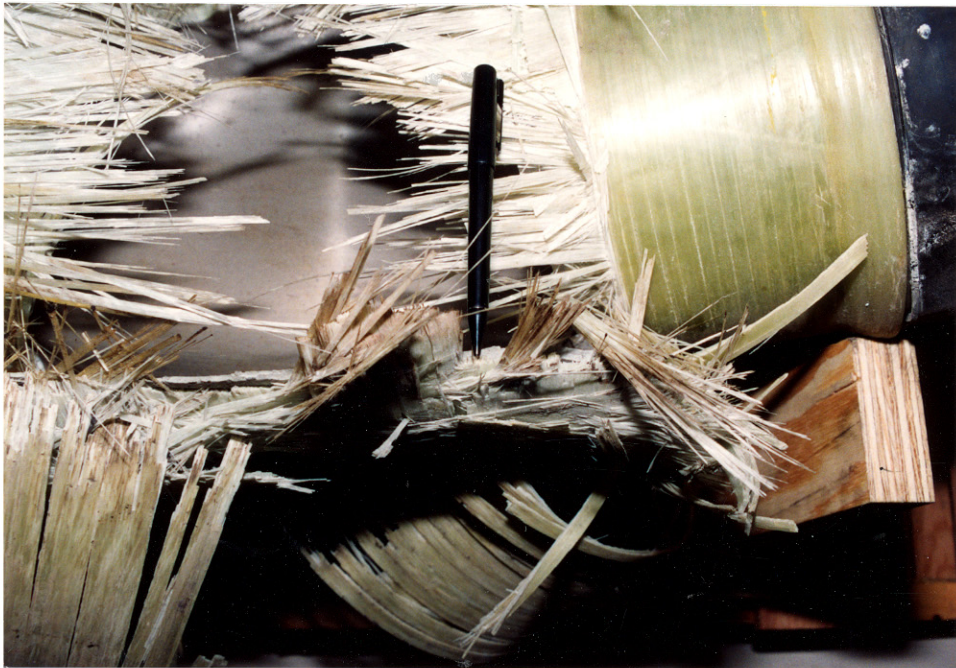
42. Overhead view of the right bottom side of the tank showing the edge of the aluminum tank and composite wrap with the forward end of the tank along the left side of the photograph

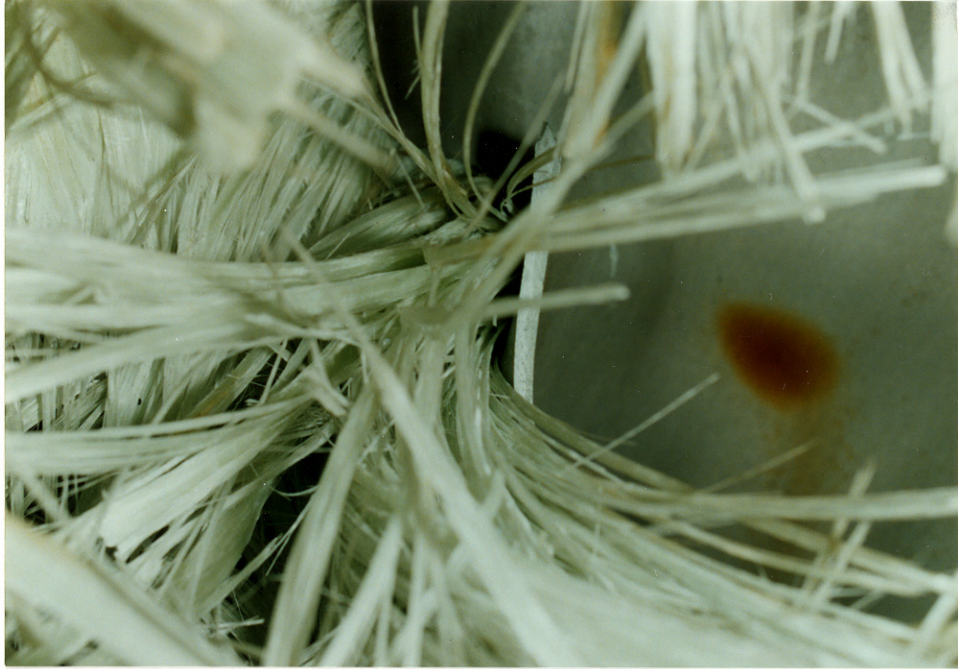
45. Close-up view of the left side of the tank with the forward end of the tank along the top of the photograph

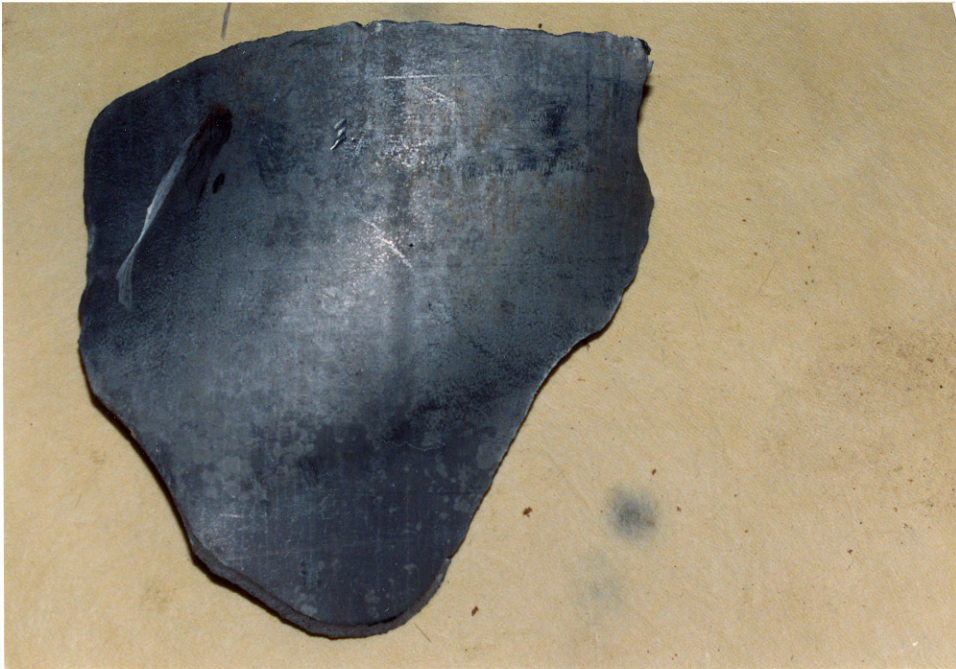
48. View of a fragment from the bottom left side of the aluminum CNG tank
